NATIONAL BUREAU OF STANDARDS REPORT

6367

A STUDY OF THE CAUSES OF FAILURE OF THE BURNERS AND UPPER AIR TUBES IN THE ARMY TENT STOVE

April 10, 1959

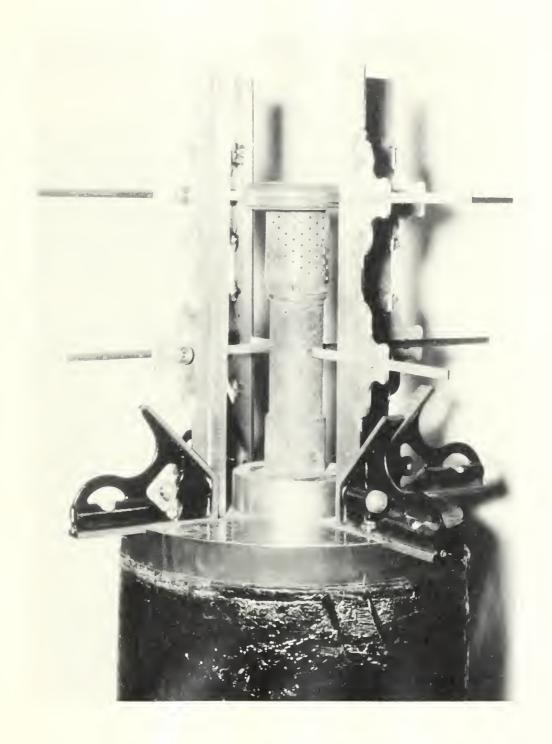
At the end of 150, 750, 1550, and 2000 hours of operation, the tubes were removed from the stoves for inspection and measurement for deformation. At none of these inspection periods was any visible deformation noted nor did any of the measurements show a change from those recorded before firing. The jig used for determining whether or not any deformation had occurred is shown in Fig. 5.

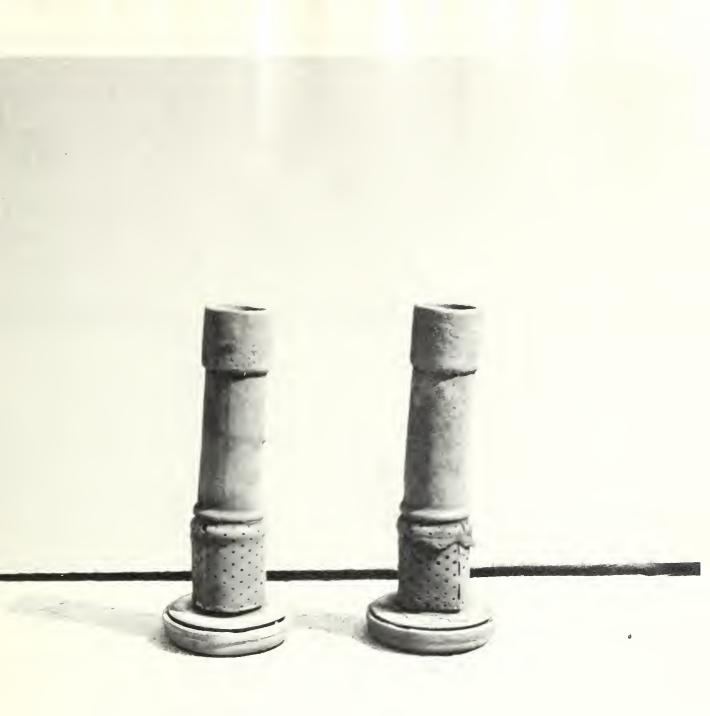
During this period three of the upper air tubes deformed by bending in the column below the cap. Two of these are shown in photographs 7 and 8. One of the tubes that deformed was from the original group of twelve commercial specimens submitted by the QMR&E Command and was identified as No. 2 and also as 23926-6. It had been operated for 4457 hours at a firing rate of 24 ml/min followed by a period of 1059 hours at a firing rate of 35 ml/min for a total of 5516 hours. It deformed at the higher firing rate.

A second deformed specimen was identified as tube 13-G and was a used tube received from Jeffersonville Quartermaster Depot with unknown history of use. It was operated during these tests for a period of 2951 hours at a firing rate of 35 ml/min and deformed during this period. The third specimen which deformed, identified as specimen 30-J, was a used tube received from Jeffersonville Quartermaster Depot. It was operated for several hundred hours during these tests at a firing rate of 38 ml/min. In addition to being bent, tube J had increased in height by about 1/4-inch during the tests at this firing rate. This is not the same J specimen chosen for chemical analysis, as reported in Section VII of this report.

The microstructures of tubes No. 2 and 13-G near the bend showed that the pearlite in these sections was completely decomposed indicating that these tubes had been operated at higher temperatures than those previously examined but that they had not reached the transformation temperature. There were differences in the microstructure on the thin and thick sides of these two specimens near the bend that could be explained if the tempera-

The reason for the deformation of these tubes could not be positively established from the operational tests and the metallurgical studies, but a theory is advanced in the Section on Discussion and Conclusions which is generally supported by the observed results.

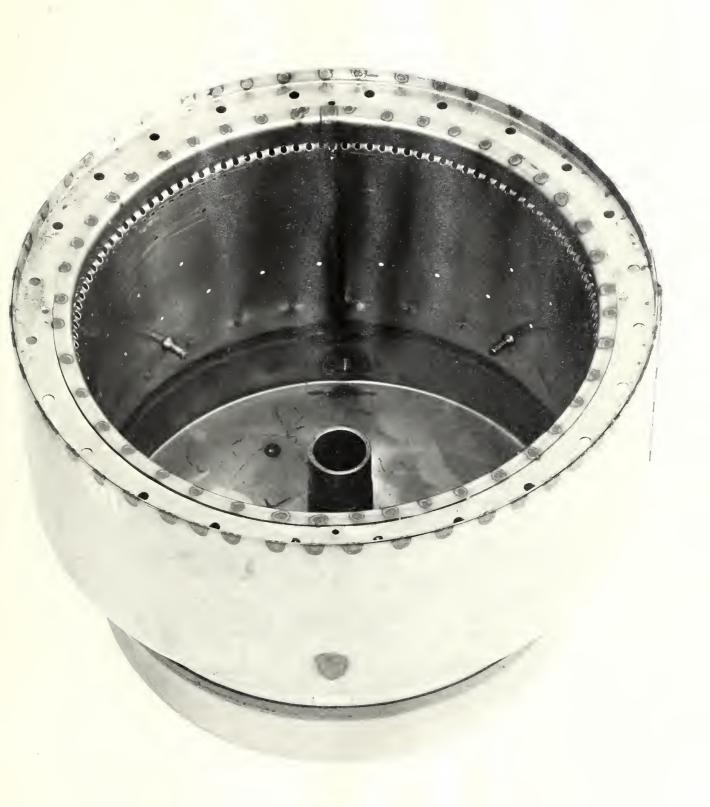
The tests of the experimental upper air tubes cast by the NBS foundry were continued for slightly over 2000 hours. During this period none of the tubes failed by bending; but six tubes of Type 2, two tubes of Type 1, and one tube of Type 3 failed by exfoliation at the base. The appearance of these exfoliated tubes is shown clearly in Fig. 1 of Appendix IV. A spectrochemical analysis of the exfoliated region showed a lead content of 0.05 to 0.5 percent, probably attributable to the leaded gasoline used

as fuel. Microstructures of the exfoliated region showed considerable slag penetration and voids. The 2 tubes of Type 1 that failed, had operated for 453 and 694 hours, respectively; the one tube of Type 3 that failed, had been fired for 1106 hours; and the 6 tubes of Type 2 failed after firing periods ranging from 316 to 1140 hours.

The tests showed the superiority of Type 1 and 3 tubes as compared to Type 2 tubes. It is probable that the superior quality of Types 1 and 3 is dependent on differences in chemical composition and microstructure. Differences in cooling rate of the castings would also affect the microstructures. It will be noted that the highest incidence of failure occurred in the Type 2 tube with the highest silicon content and the lowest phosphorous content. Conversely, the fewest failures occurred in the Type 3 tubes with the lowest silicon content and the highest phosphorous content. These relative frequencies of failure may or may not be significant but it is known that high carbon and/or silicon contents decreases the growth resistance of ordinary gray irons while phosphorous will resist growth and oxidation to some extent.

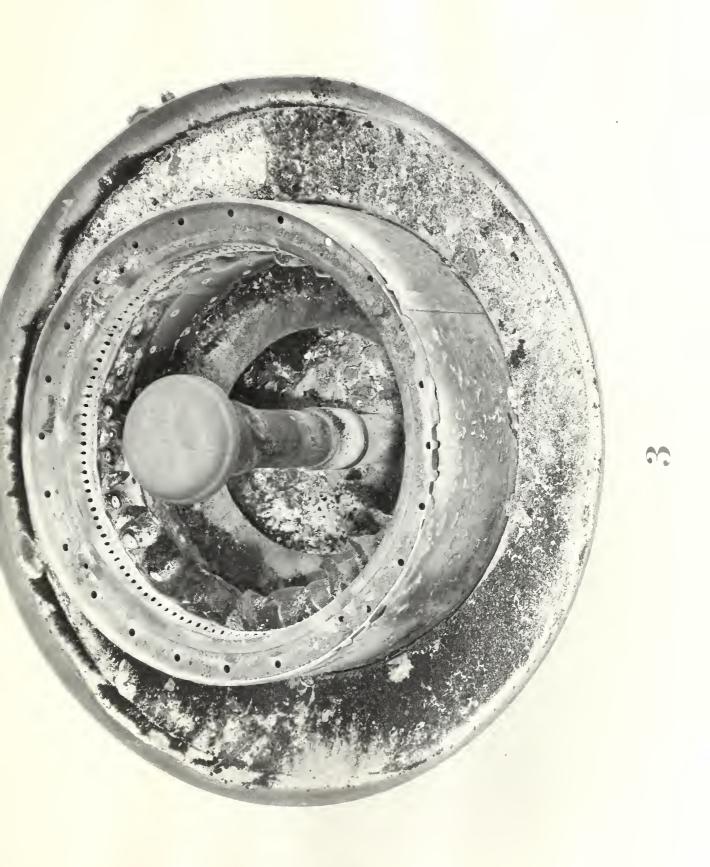
Fig 11

At the end of 2000 hours of operation both Style 2 burners and one Style 6 burner had holes in the upper edge of the air casing. All remaining parts in all twelve burners were in good condition.

At the end of 3000 hours of operation, which was the conclusion of the tests, the low carbon steel air casings had all suffered noticeable deterioration ranging from partial separation near the support ring to complete oxidation of the steel. All other components of the burners were in good condition. Fig. 10-16 inclusive show the nature of the deterioration of the air casings. The numbers below the burners are the corresponding stove numbers and can be used to identify the styles of the burners by referring to Table 11. Fig. 11 shows a style 2 burner and Fig. 13 a style 4 burner before cleaning and reveals the carbon deposits near the air holes on the inside walls of the burner and the considerable amount of soot and scale that had fallen into the burner. Fig. 15 shows a style 6 burner fully assembled after cleaning and Fig. 16 shows the same burner with the combustion ring, low fire ring, and upper air tube removed to indicate the condition of the interior.
